AMD Alchemy™ Au1100™ Processor

Document Revision History

The AMD Alchemy™ Au1100™ processor may contain design defects or errors known as errata that cause its behavior to differ from the published specification. Characterized *Device Errata* are documented in this Specification Update.

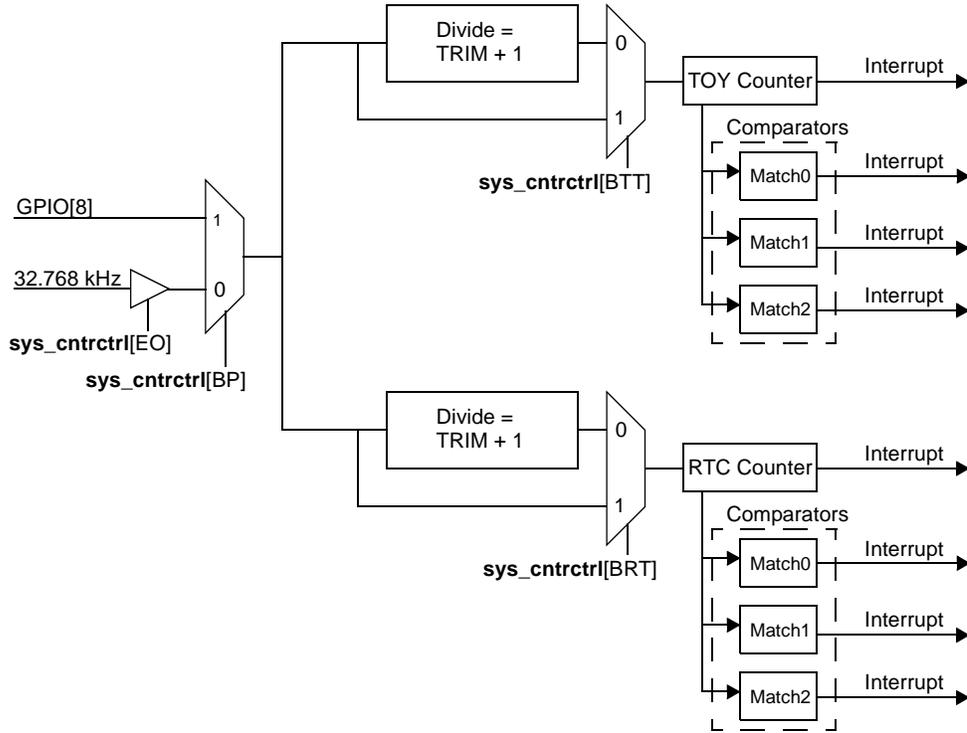
Replace Figure 37. TOY and RTC Block Diagram and 7.2.1 Time of Year Clock and Real Time Clock Registers with the following new material.

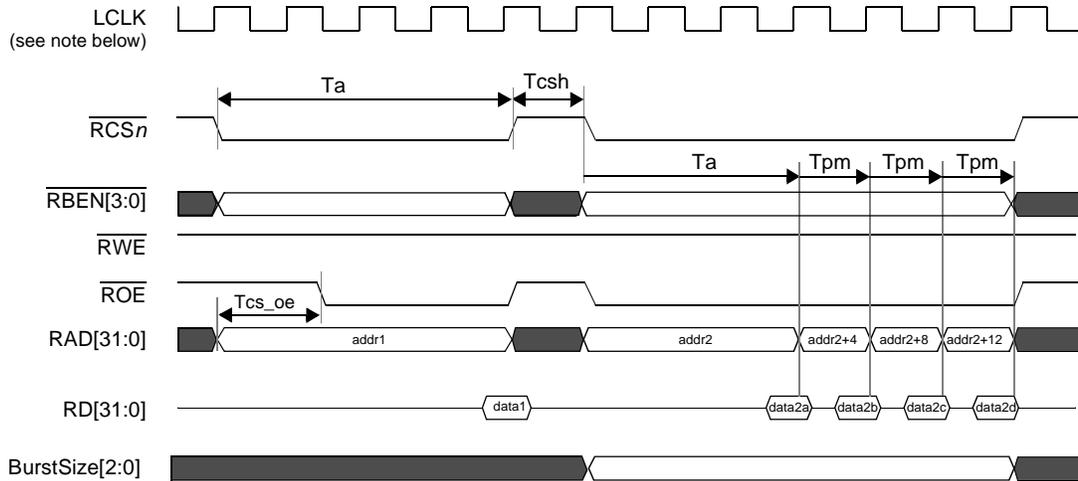
Figure 8. Static Memory Read Timing (Single Read Followed by Burst)

13. For the static bus controller, replace Figure 8.

On page 73, replace Figure 8 with the following:
