## SOME NOTES ON STABILOCK 4040 CPU BATTERIES

ORIGINAL OBSERVATIONS October 2009

## FITTING REPLACEMENT BATTERY November 2009

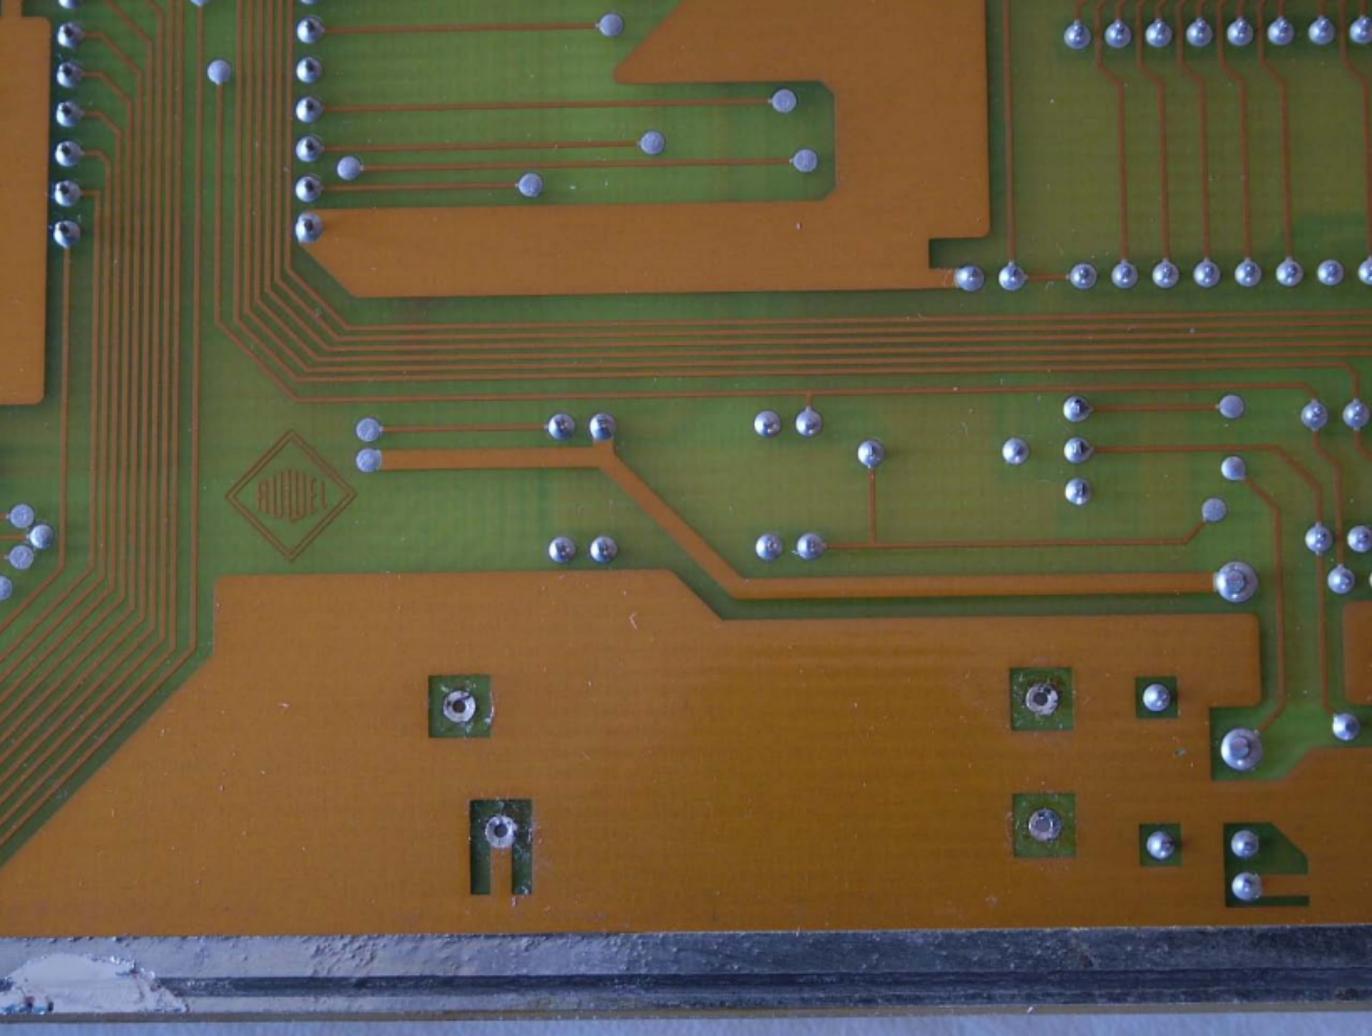
After removing the original battery I found it had leaked after all, around the negative pin on the base of the unit, and the seepage had flowed under the conformal coating on the PCB and caused a circle of localised surface corrosion on the upper ground plane around the pin, with a diameter of just over 1/4 inch.

1 – The PCB with original battery removed and corroded area cleaned.

After removing the circle of lifted conformal coating the PCB was cleaned successfully by a combination of scraping away the corroded surface deposits and polishing with steel wool to leave clean copper.

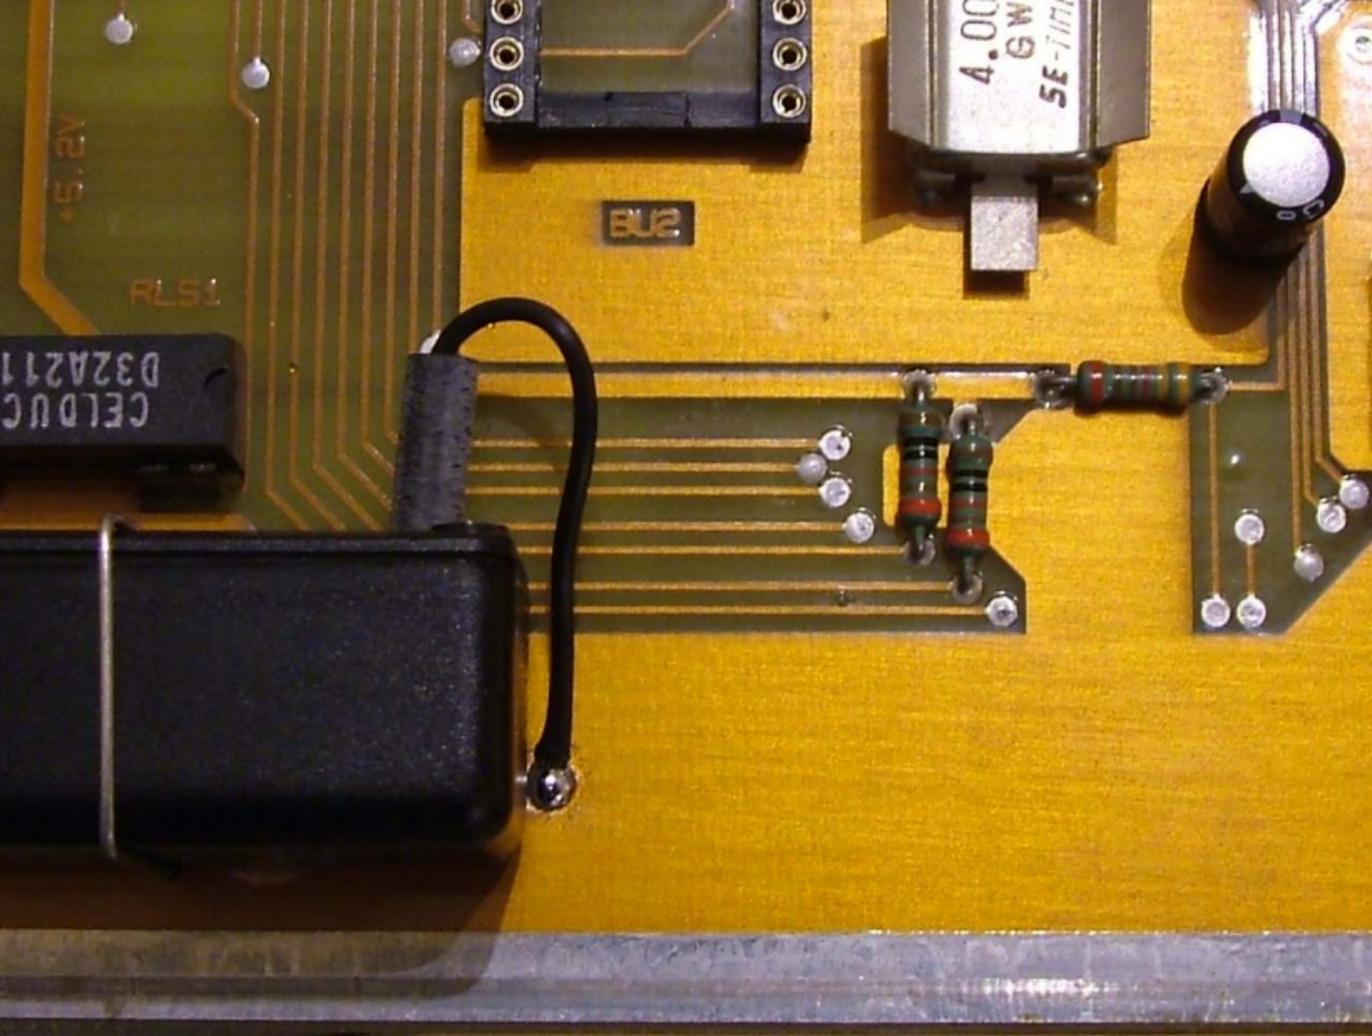
7 – Top of PCB showing replacement battery fitted.

Because of this, and also because an attempt to test fit the battery into a socket resulted in the positive pin pushing back slightly into the battery housing, the battery was mounted on its side and attached to the CPU board with strong double sided tape. Two holes were drilled through the ground plane, and the conformal coating cleared, so that a tinned copper wire restraining link could also be fitted over the battery and soldered to the ground plane on the other side of the PCB.

The two spare pins on the battery, normally used for mounting purposes only, were cut back to the body and red and black flexible wire links soldered to the positive and negative terminals respectively. The red lead was soldered to the original positive PCB pad but the original negative PCB hole was now covered by the battery so a small patch was cleared on the ground plane nearby and the black lead soldered to that. As a result it will be much easier to remove the battery in the future and the risk of PCB damage when doing so significantly reduced
