Failure Analysis Report

#	Marking	Date Code	Failure Mode	Visible Damage
1	BA6F11	6F	GDS	No

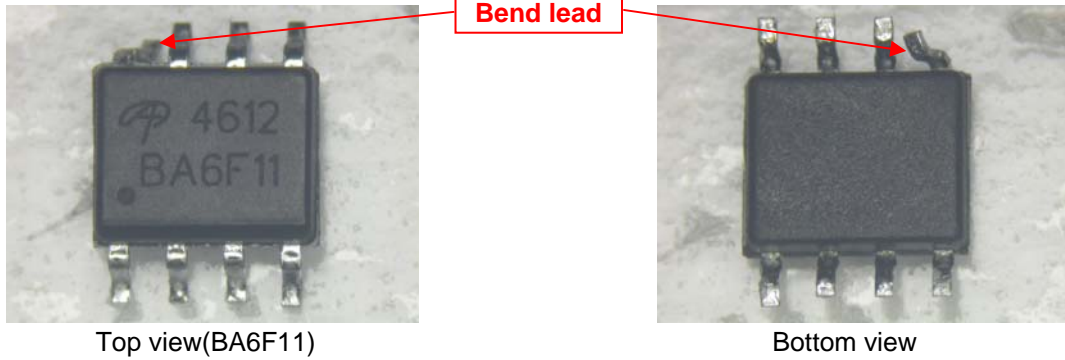
SN1

Pin4 lead bend was observed.
Solder and flux were observed on the external leads.

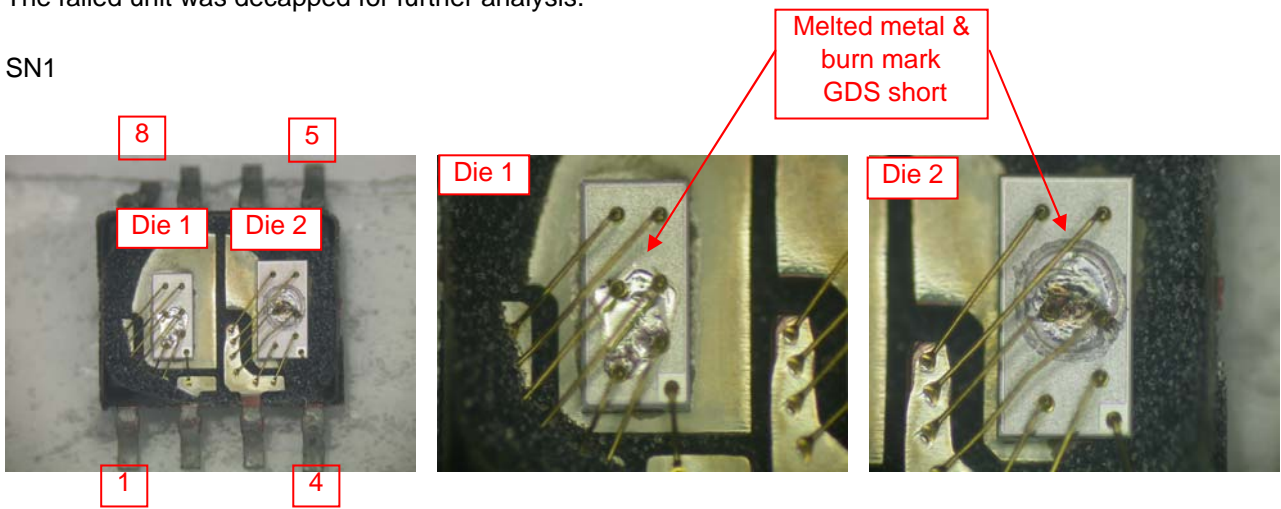
SN1

Note: Melted metal & burn mark were found on source active region.

EOS	<p>The observed carbonized molding compound and alloyed / discolored metal on the active region are typical result of electrical overstress(EOS) due to high current flow and the associated high heat generation. This indicated that the device might operate out of safe-operating-area (SOA) which caused the electrical overstress damage.</p> <p>In general, the high heat that carbonization need is caused by high current flow in device and the over heat will drive the temperature up to the burning point of molding compound and make it carbonized or make metal on the device melted.</p> <p>Review of the wafer and final test yield summary showed that the shipped units with the yield above the average and passed both AOS outgoing final test and QA screen. AOS acknowledge the failure observed by the customer and appreciate the customer's time and effort to help AOS responding the suspected issue and correct some deficiency. However, the obvious symptom of root cause could be masked out by burnt mark/carbonized molding compound, AOS has recorded this reported failure using a tracking no. For just one failure was returned from customer, it also could be an infant mortality or random failure. Should the units continue to fail, Logah may consult with AOS application engineer for further assistance.</p>
