Model 2450 System SourceMeter®

Version v1.0.0 Firmware Release Notes

Version v1.0.0 Release

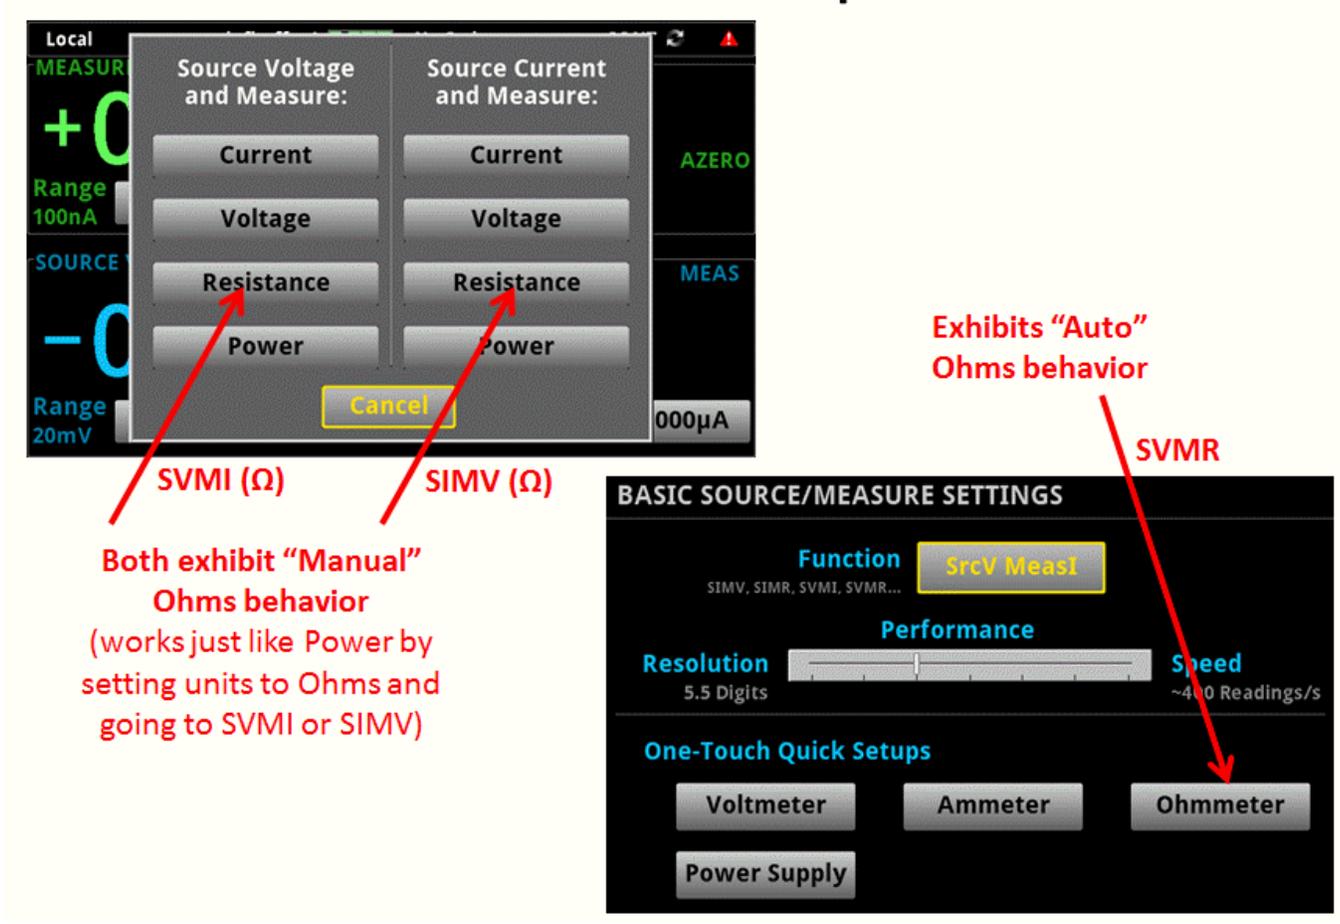
D) Resistance Mode Changes: Auto Ohms vs. Manual Ohms:

- a. Significant changes were made to the way resistance mode was documented in Revision A of the 2450 Reference Manual. Below is a summary of differences in the Reference Manual vs. the actual implementation. The Reference Manual will be updated to reflect these changes in Revision B of the 2450 Reference Manual. Sections affected are 2-91, 6-46, 8-116, and 9-14.

- b. The term “Auto Ohms” has been removed from the user interface. The user interface now presents “Ohmmeter” as a One-Touch Quick Setup (see diagram below).

- c. The term “Manual Ohms” has been removed from the user interface. The user interface now presents “Resistance” as a Measure function vs. Voltage or Current Source (see diagram below).
