The Marconi communication test set 2955 series has a common fault – the 10MHz oscillator is prone to failure. Shows as a breaking up of the display and general lockup. It is not a good idea to use your unit if it is showing this symptom as it can corrupt the eeprom, see below – here is one way to fix it.

Marconi 2955  
replacement TXCO  
courtesy VK6JBN

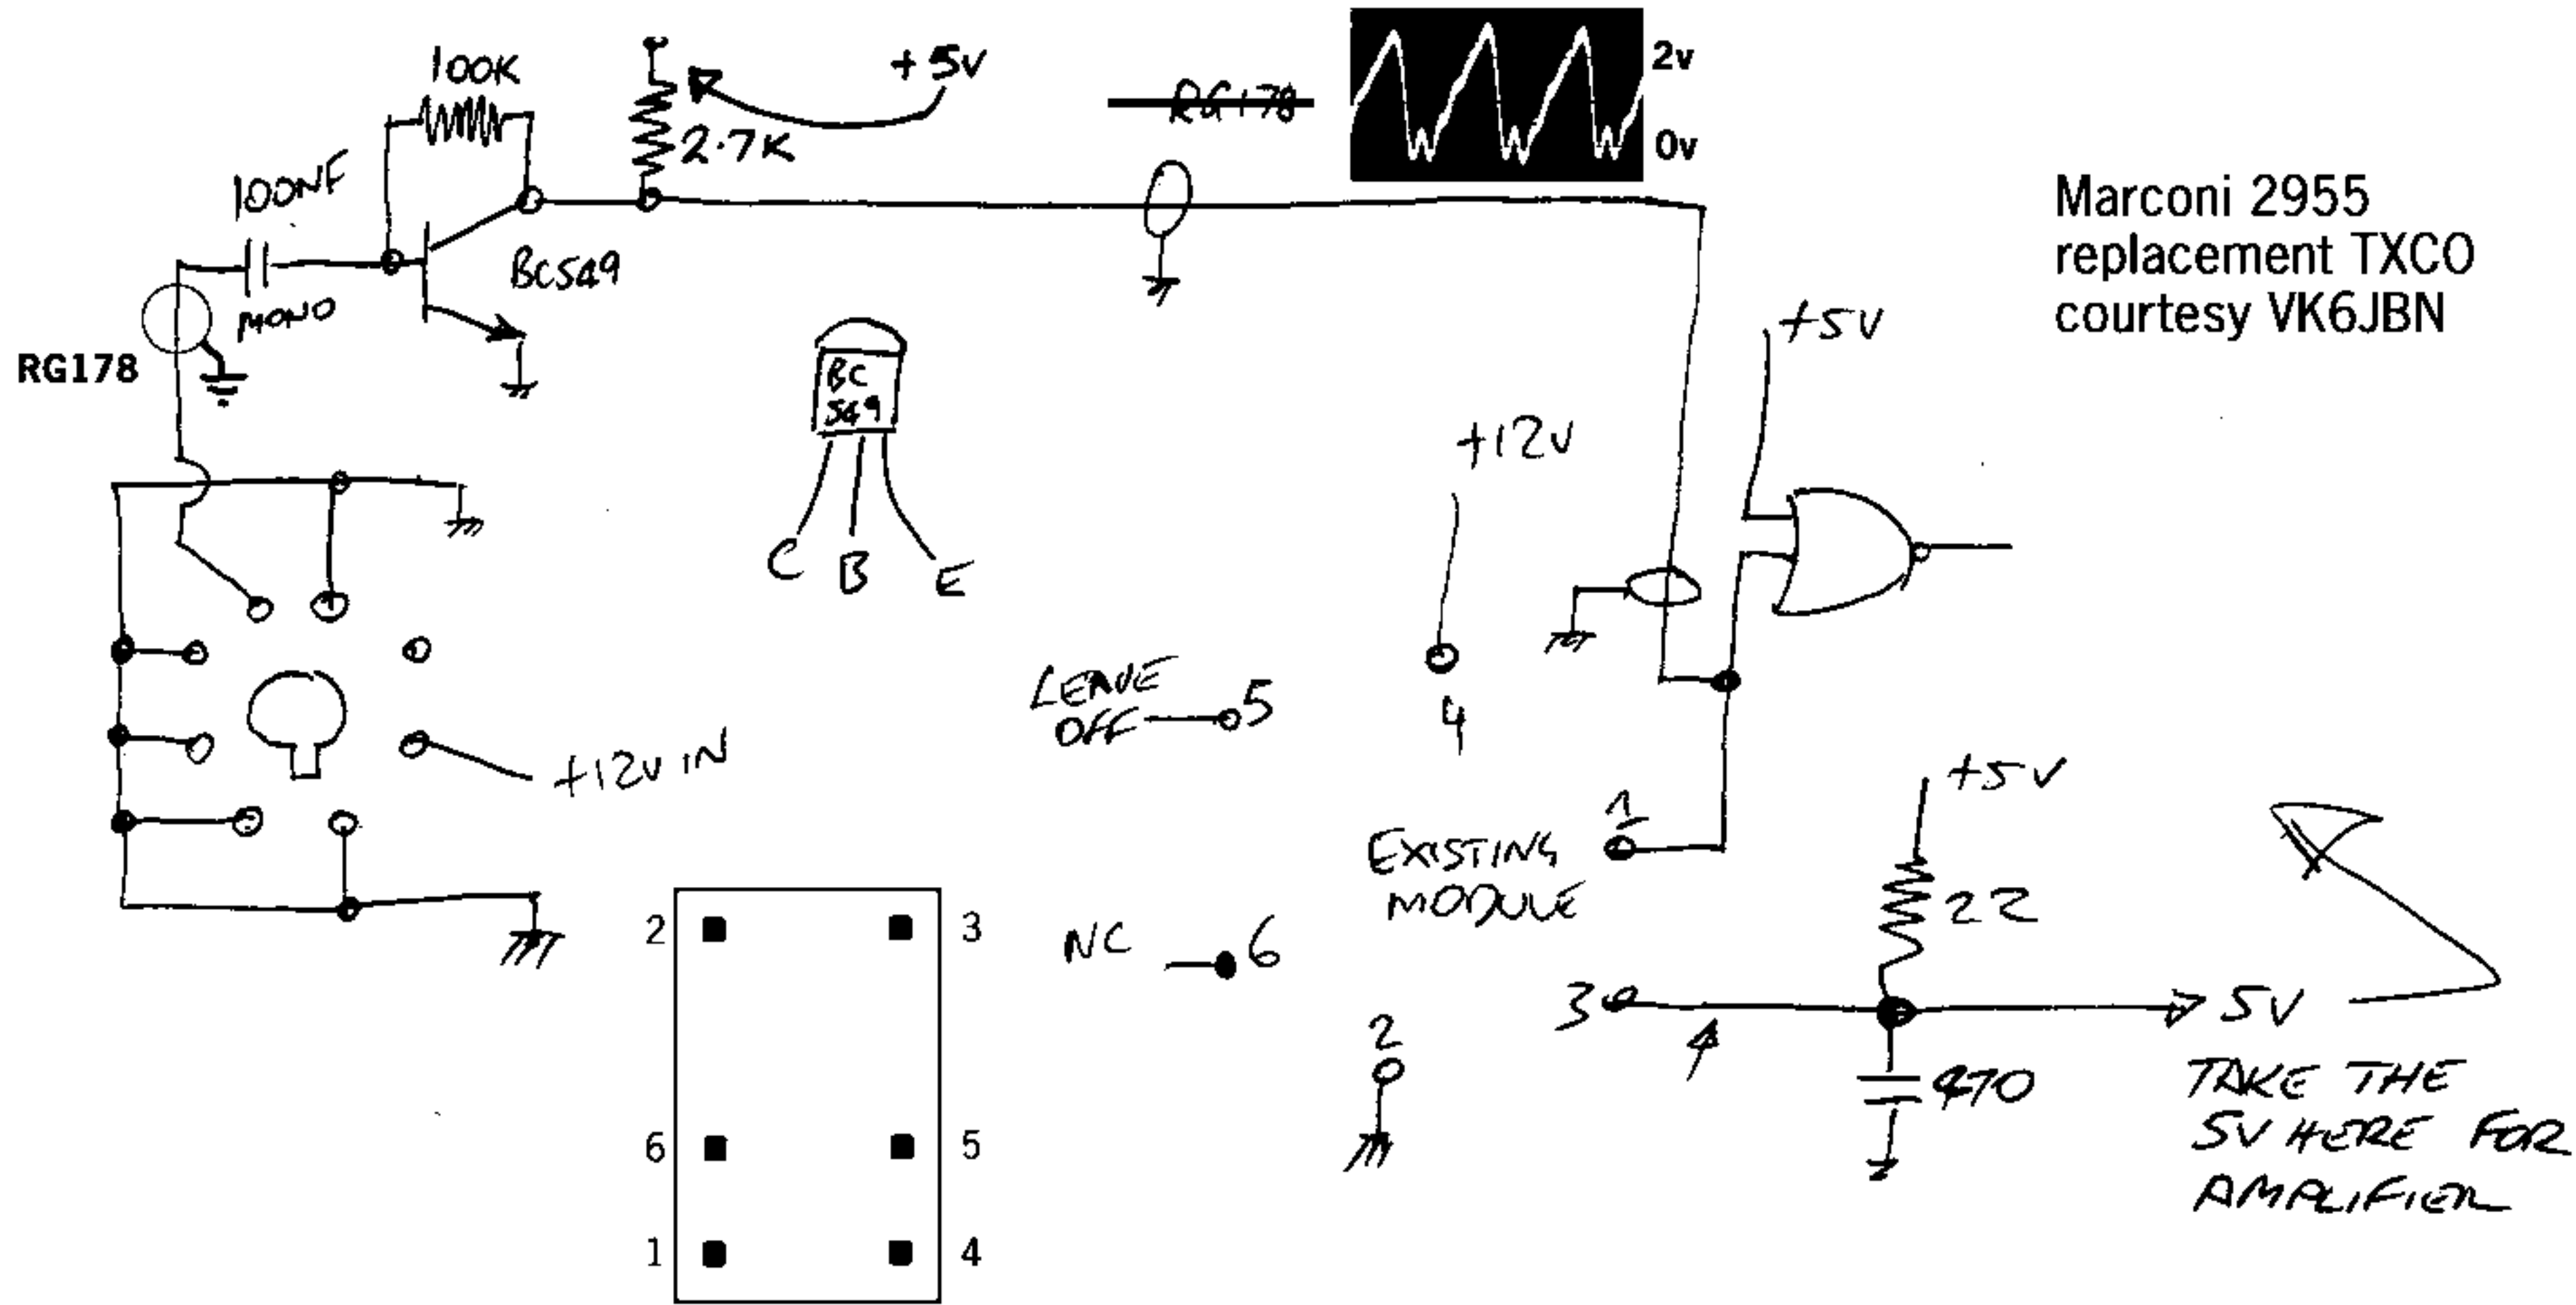
TAKE THE  
5V HERE FOR  
AMPLIFIER

+5V<sub>3</sub>

OUT<sub>1</sub>

PM14

+12V<sub>4</sub>

It's a small grey box located towards the rear of the long crt pcb. There is a blue multiturn pot directly above it. That sets the frequency. It will lock the unit up if it fails during warmup or operation. It supplies all the timing signals for the 2955 including the display. Best way to fix it is remove and install a new 10mhz reference oscillator. The original oscillator is not easily sourced and they are getting too old. I fitted a 10mhz Vectron oven which fits nicely onto the side of the case directly behind the crt pcb. There is 12v on the crt board as the original oven uses 5v. You will require a transistor, a couple of resistors and a cap to "pullup" the level of the oscillator signal to 2v p-p which the Marconi needs to work. If the level is low then the unit won't start on power up. You won't obviously need to do that if you source an oven with a high level output. I suppose another way is to find a good hp oscillator on ebay.

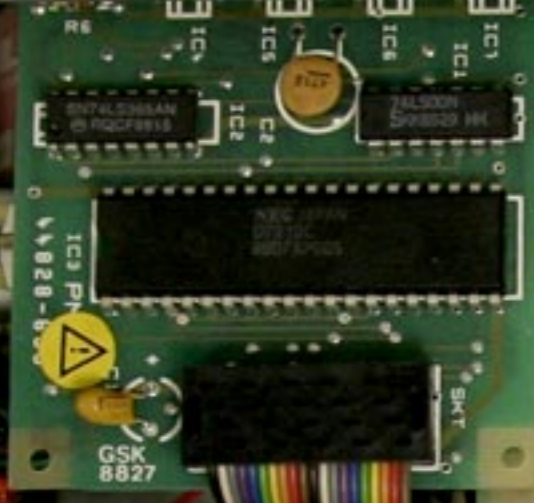
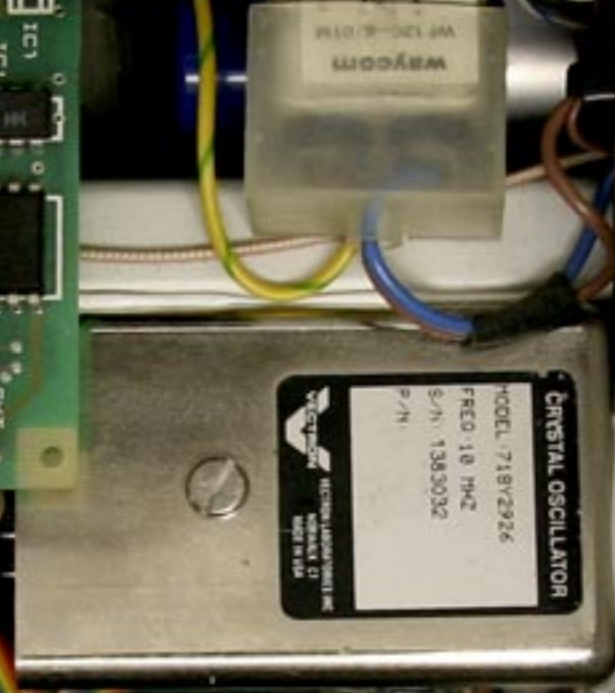
USE SCREW ON XTRAL OVERVIEW

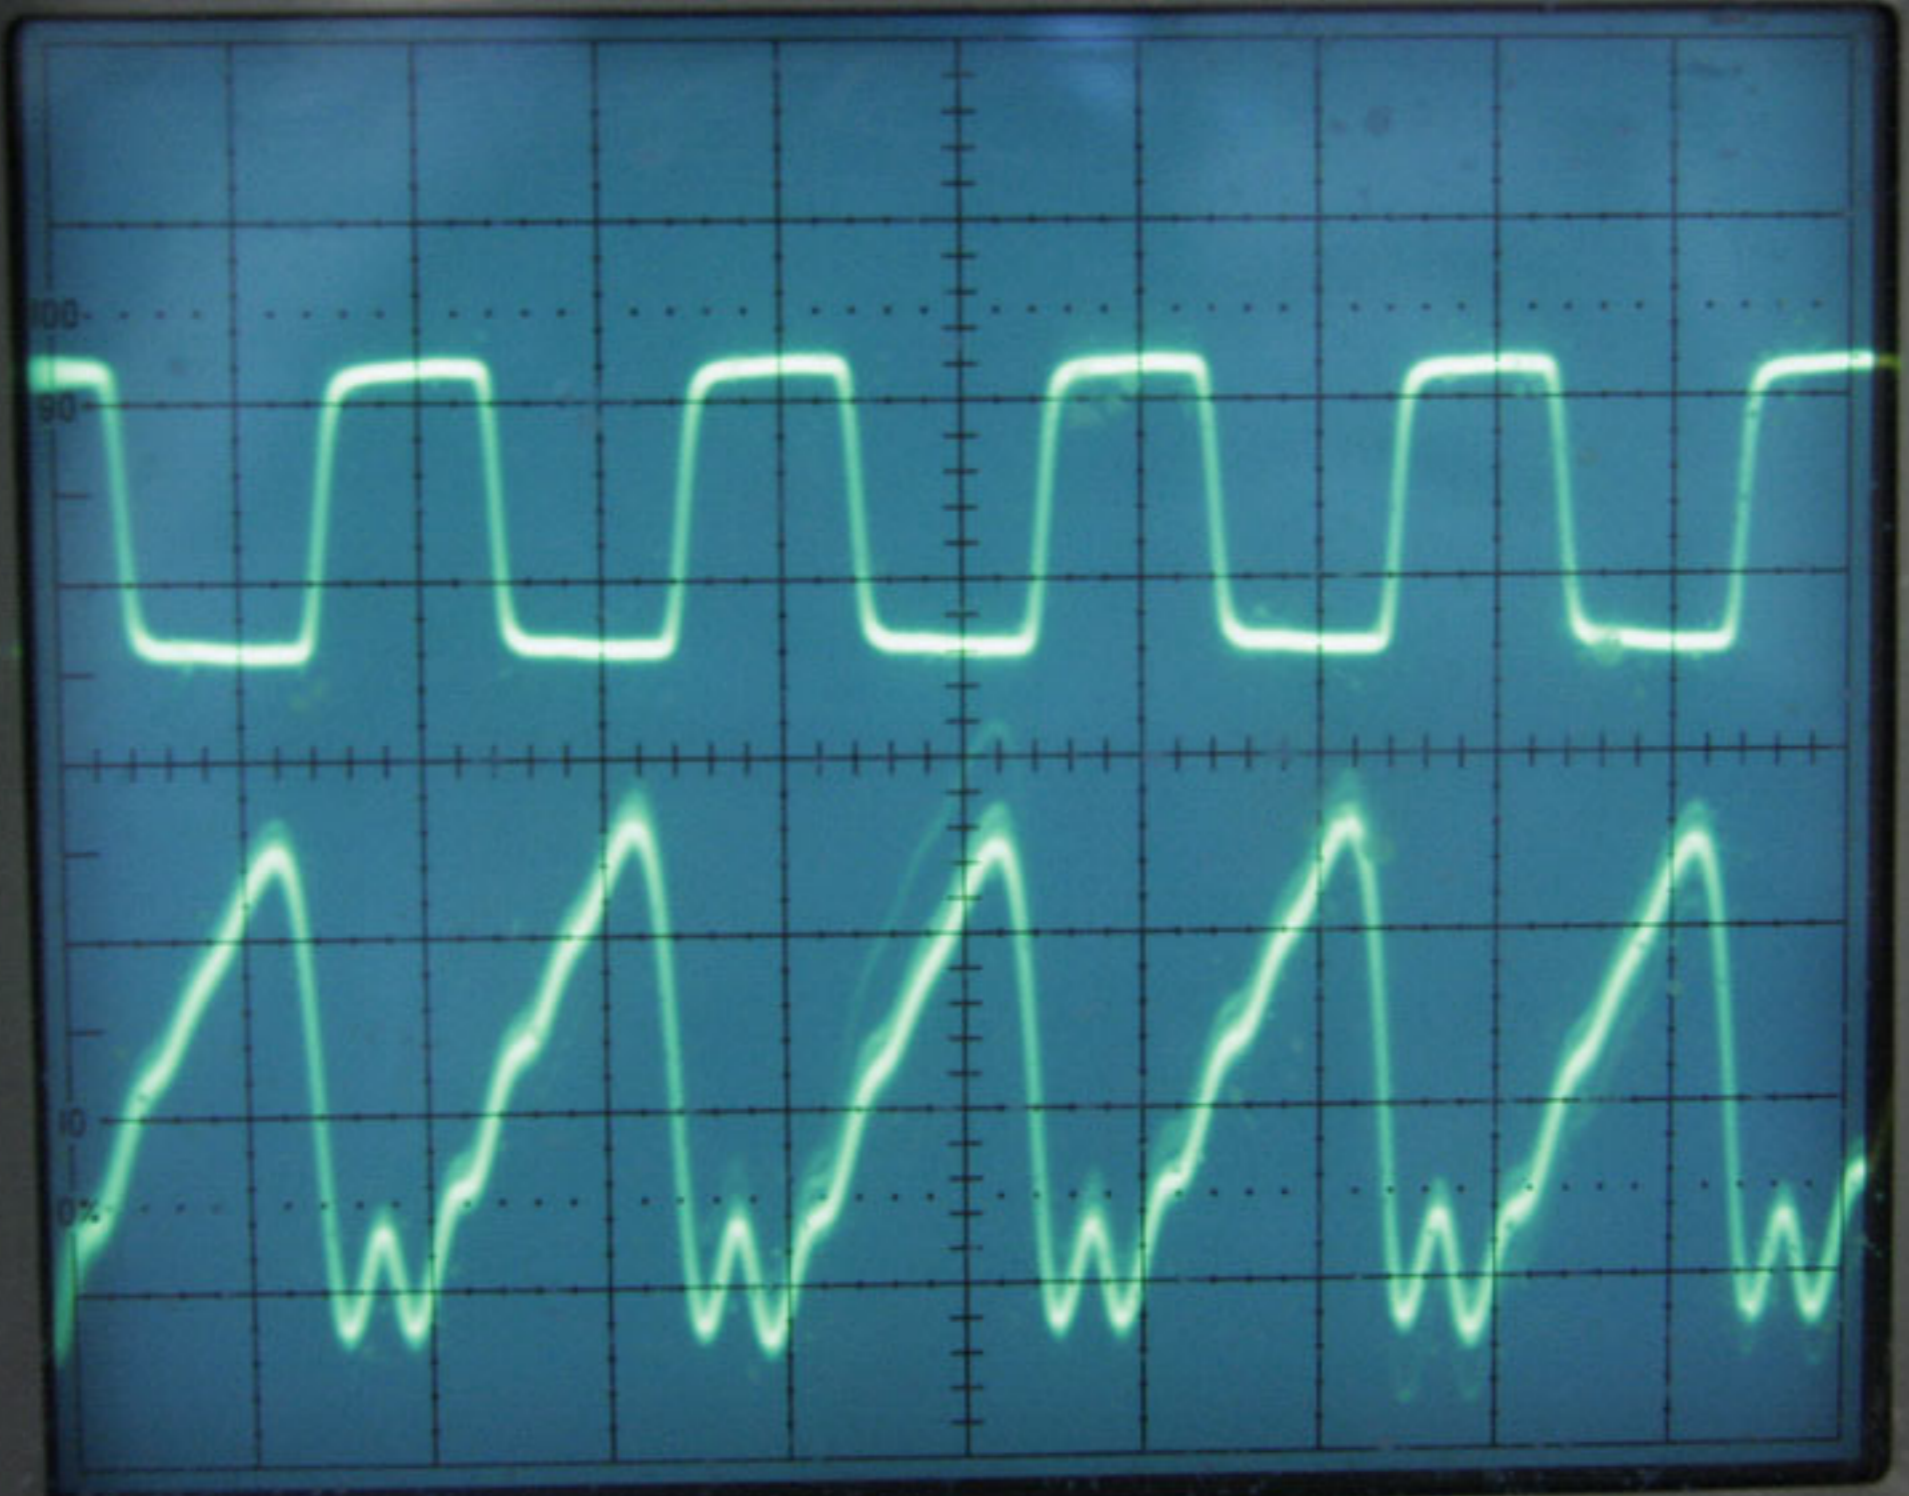
in sync with GPS fx standard

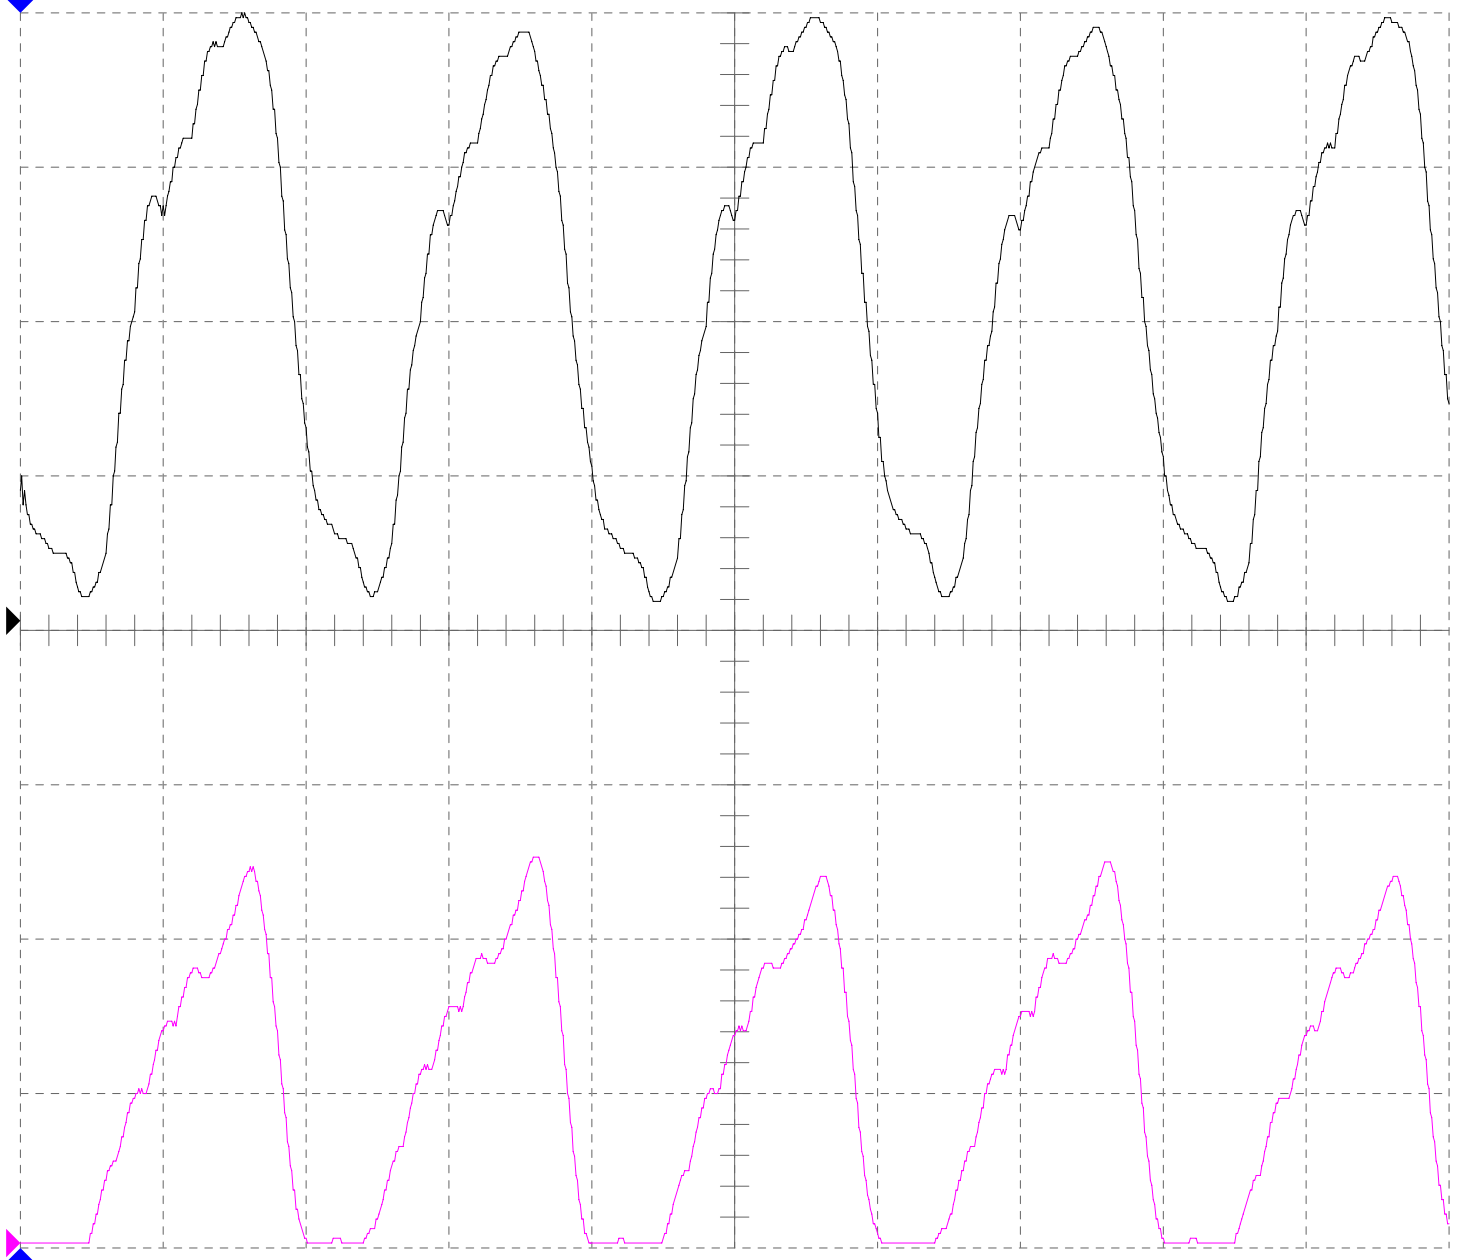
# TEST REPORT

DSO-2100 USB

SAMPLING RATE = 100MS/s

TIME DIV = 50 ns/div

CH1 VOLT DIV = 1V/div

CH2 VOLT DIV = 1V/div
