Sencore LC-102 Cable 'zeroing' issue and 'fix'

Post subject: Sencore LC-102 Cable 'zeroing' issue and 'fix'

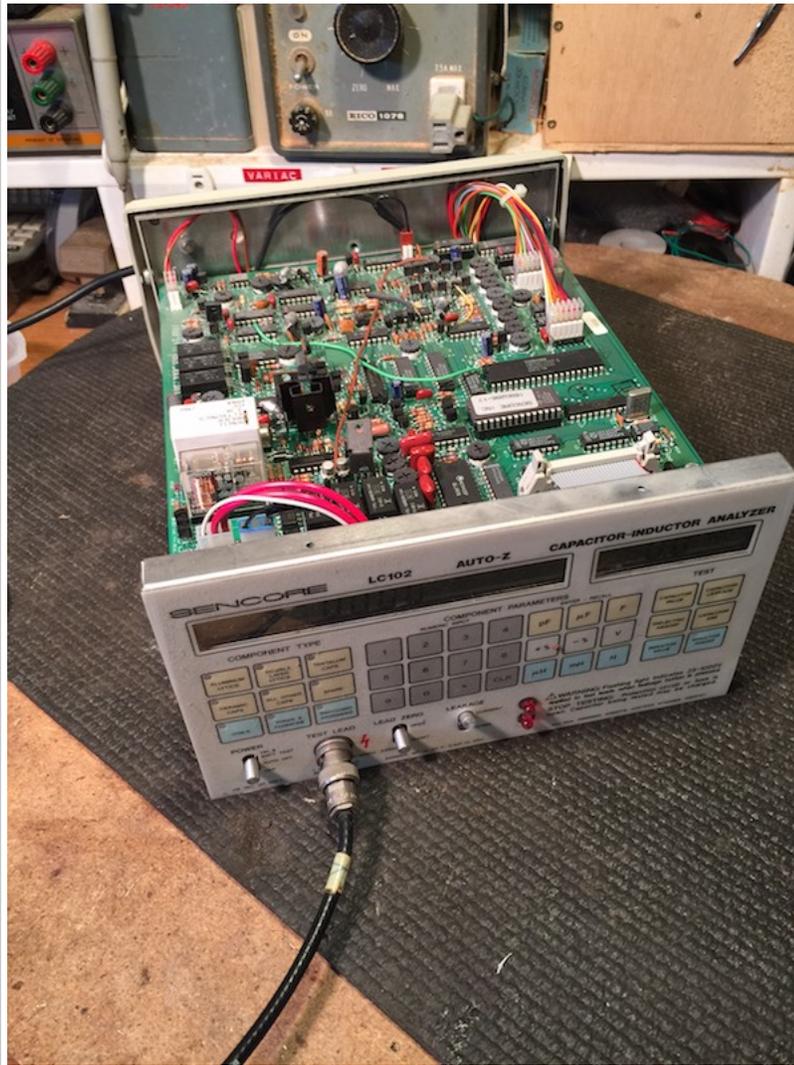
sencore1.jpg [181.78 KiB | Viewed 1064 times]

I determined the white relay was the zero function relay - and it is a simple DP/ST. Access to the underside of the relay is blocked by a pair of big 22watt resistors used to dump the cap under test and are connected to the clear relay in front of the white relay. So simply removing the relay to allow easier access to the contacts would be more invasive and the potential for damage was higher (the resistors are also glued to the board).

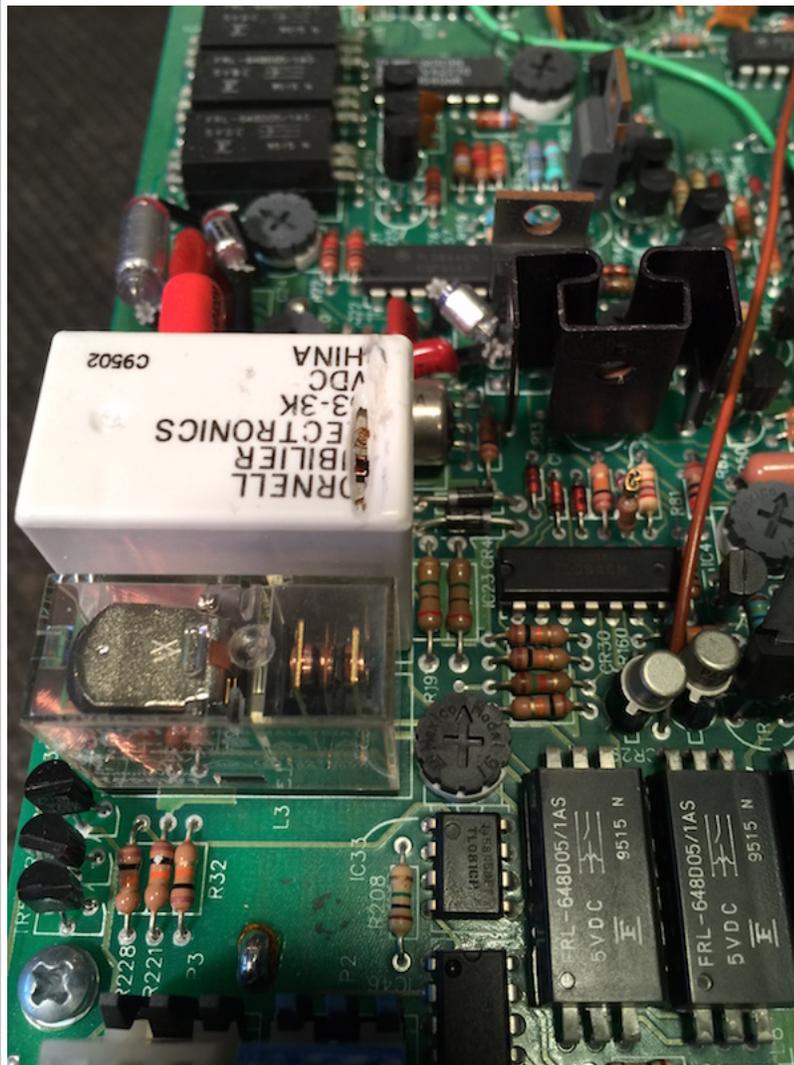
sencore2.jpg [230.88 KiB | Viewed 1064 times]

So my 'hack fix' was to gain access to the relay contacts from the top. In the past I've successfully used a small drill to allow access, but since the guts are not visible I didn't want to take a guess where to drill. So I pulled out the Dremel and gently and very slowly sliced in to the top of the relay. I think the one advantage to this method is that the Dremel cut-off wheel melts more than cuts, which keeps dust and plastic flecks to a minimum.

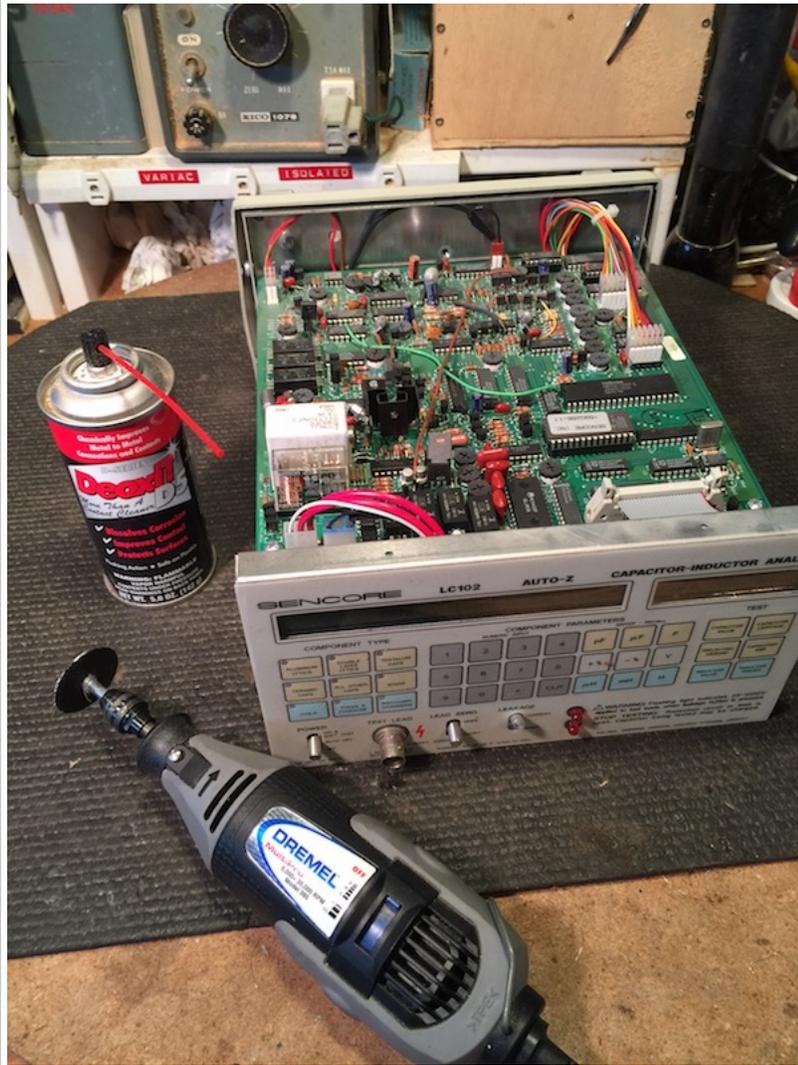
sencore3.jpg [191.95 KiB | Viewed 1064 times]

The only tools needed. I gave the contacts a squirt of De-Oxit, cleaned things up and put a strip of tape over the opening.

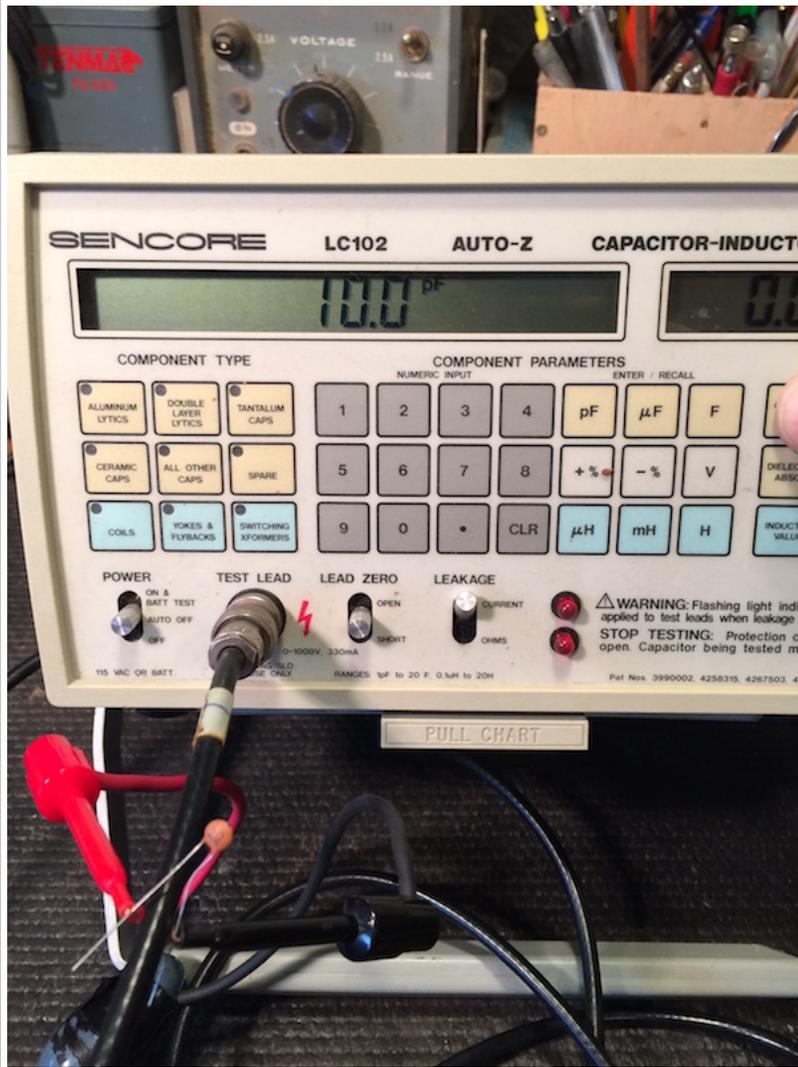
sencore5.jpg [205.33 KiB | Viewed 1064 times]

Success! I was able to zero out the cable I had made several years ago with no issue. I did some testing and things seem to be accurate and working well. As a side note, I found that with the electronic zeroing feature, the LC102 is much less finicky about capacitance, cable type and length than reported. I grabbed a few other cable, RG-58, RG-59, RG-62 at various lengths and the Sencore zeroed fine - both open and short. And, the cable I made a long while back (and use today) measures 200pF...
